# Aging Building Audit

## Stellarton Memorial Rink - Final Report

Town of Stellarton

Report > Rev. C01  
Internal ref. 657583-0001-T-31-REP-000-0001

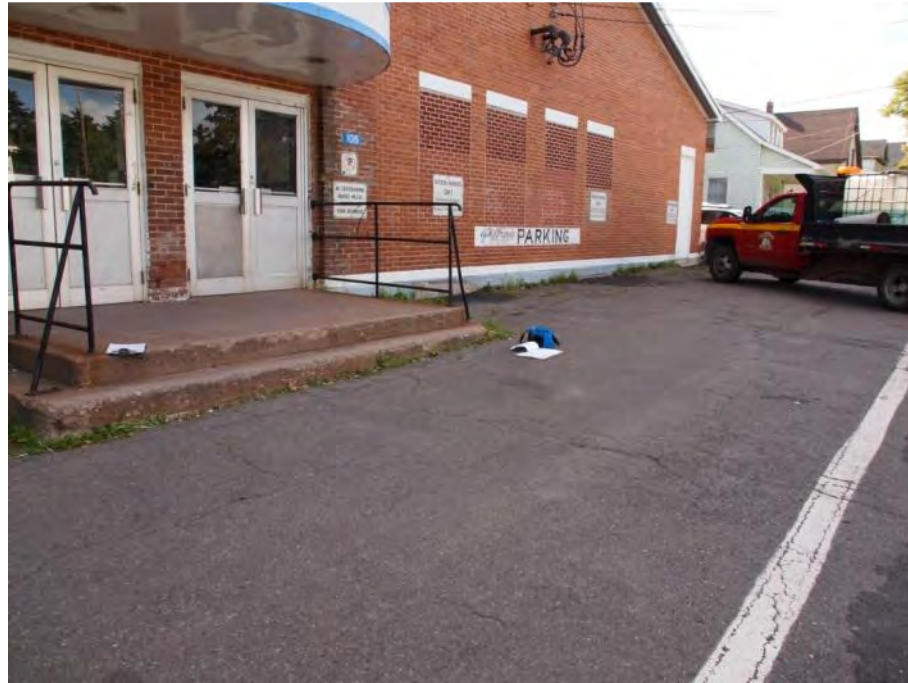
A1: Under linedated Parking near main entrance

1. Paint lines in parking area to the South of main entrance to create barrier free spaces
2. Remove vegetation adjacent to building; create gravel strip beside foundation to discourage future growth
3. Provide drainage at East and South sides of building
4. Repair/patch damaged asphalt as necessary

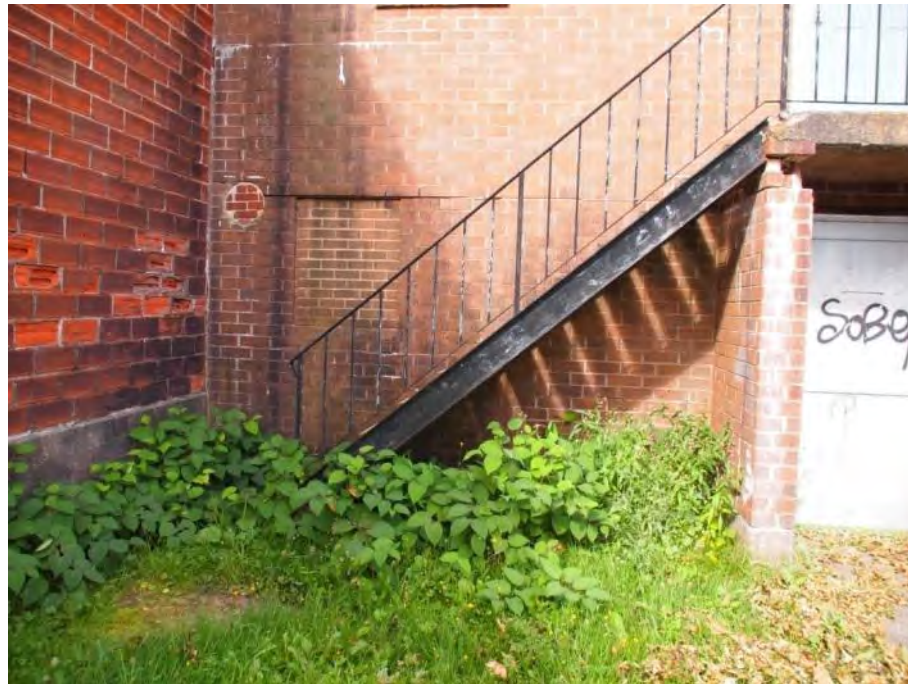
A2: Steel exit stair, uncontrolled plant growth

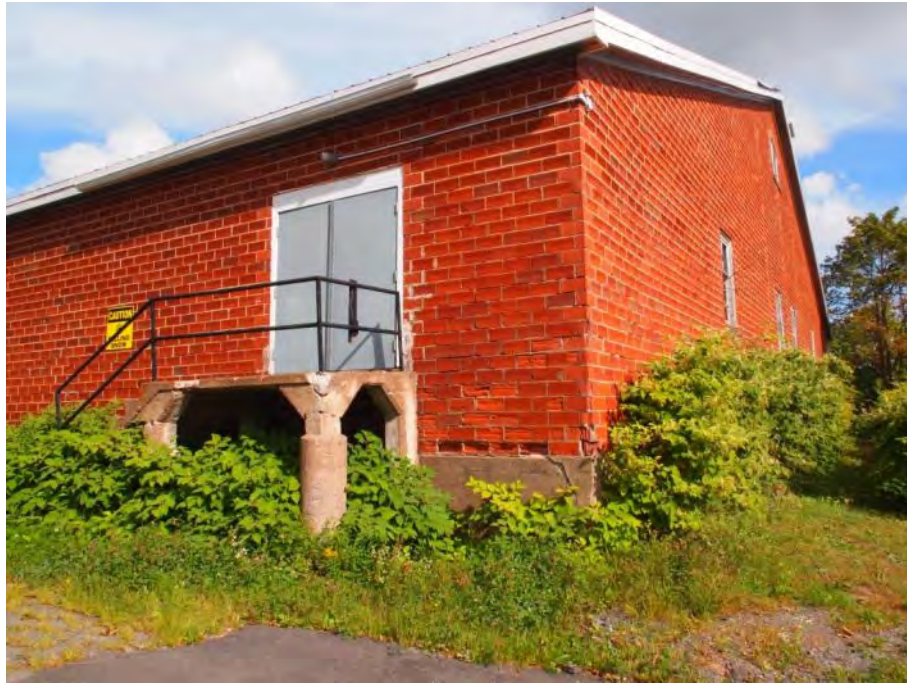
A3: Concrete exit stair, uncontrolled plant growth

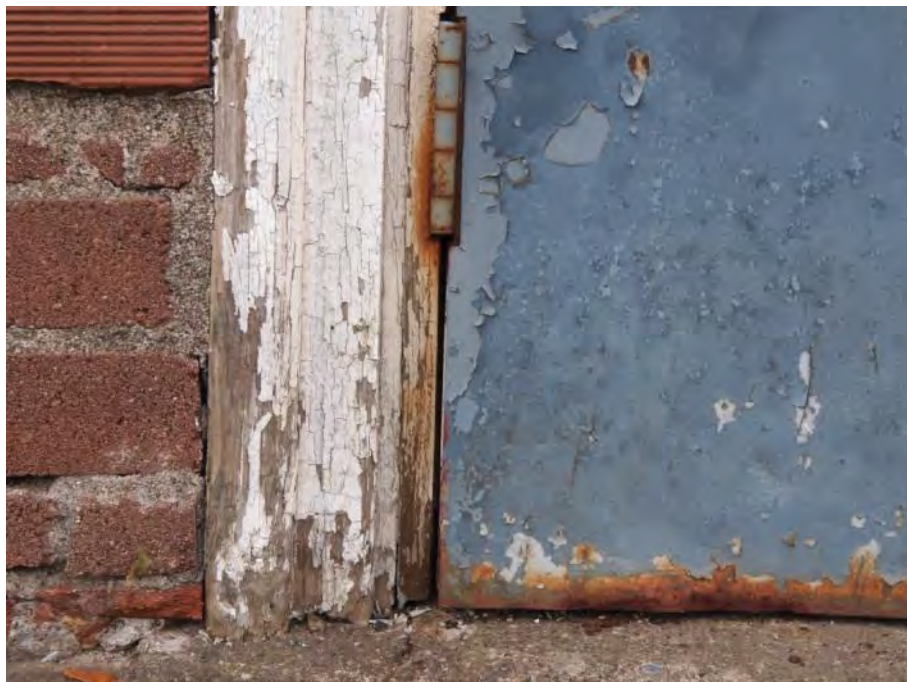
A4: Steel door detail

1. Replace all exterior doors, include emergency egress hardware
2. Infill windows on East façade with brick to match other infilled windows
3. Repair damaged corners; install bollards to prevent future collisions

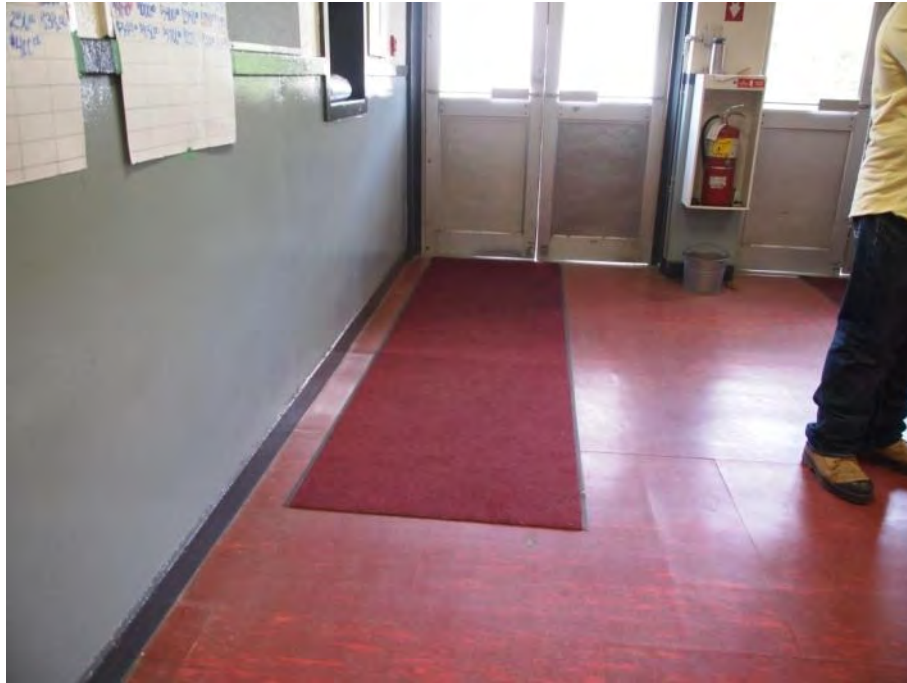
A5: Foyer. Poor door seal, non-barrier-free ticket booth

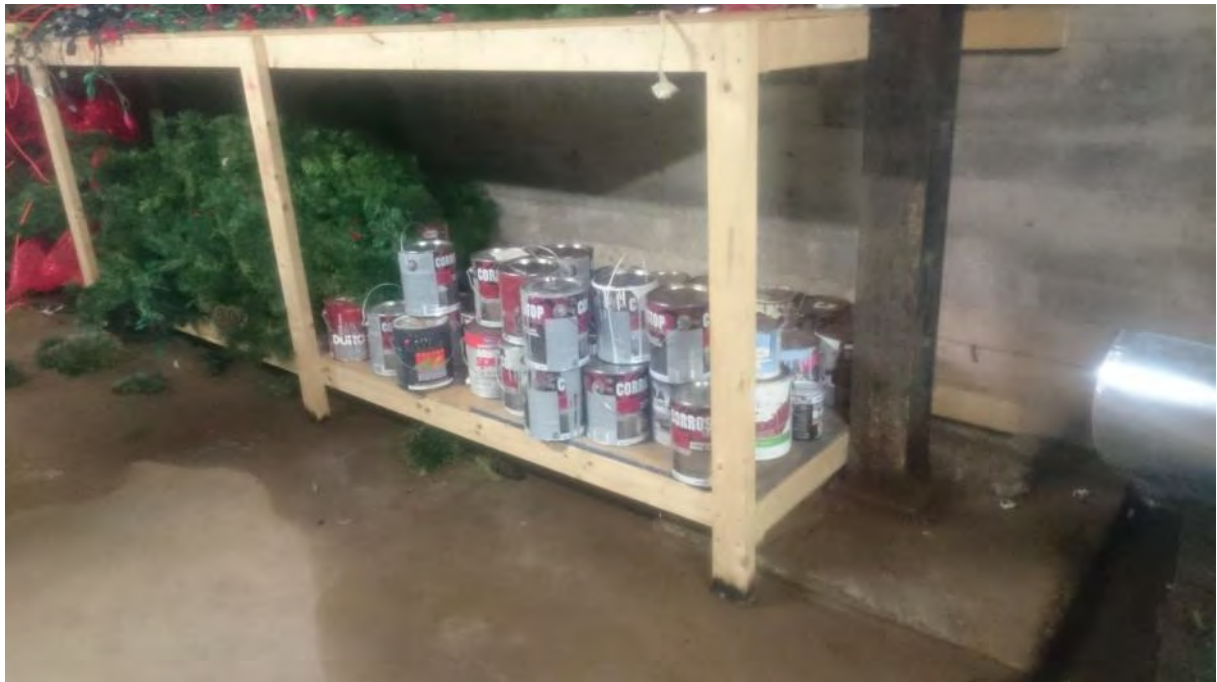
A6: Materials storage in basement electrical room

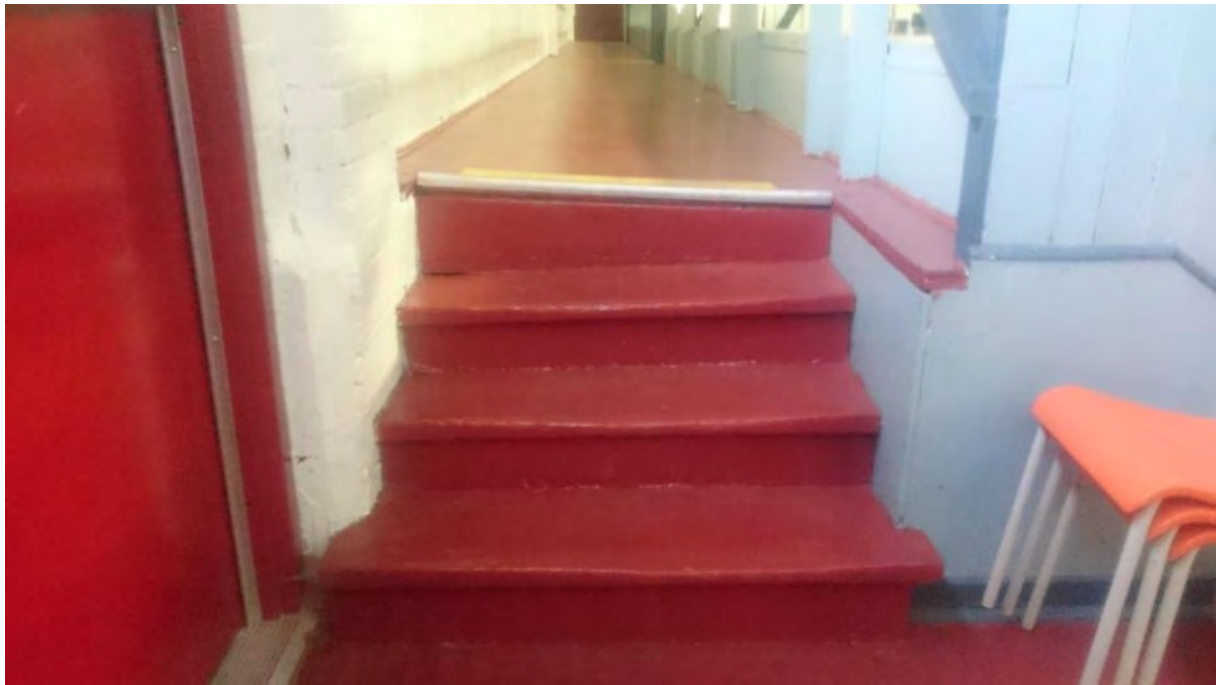
A7: Uneven stair and corridor behind stands

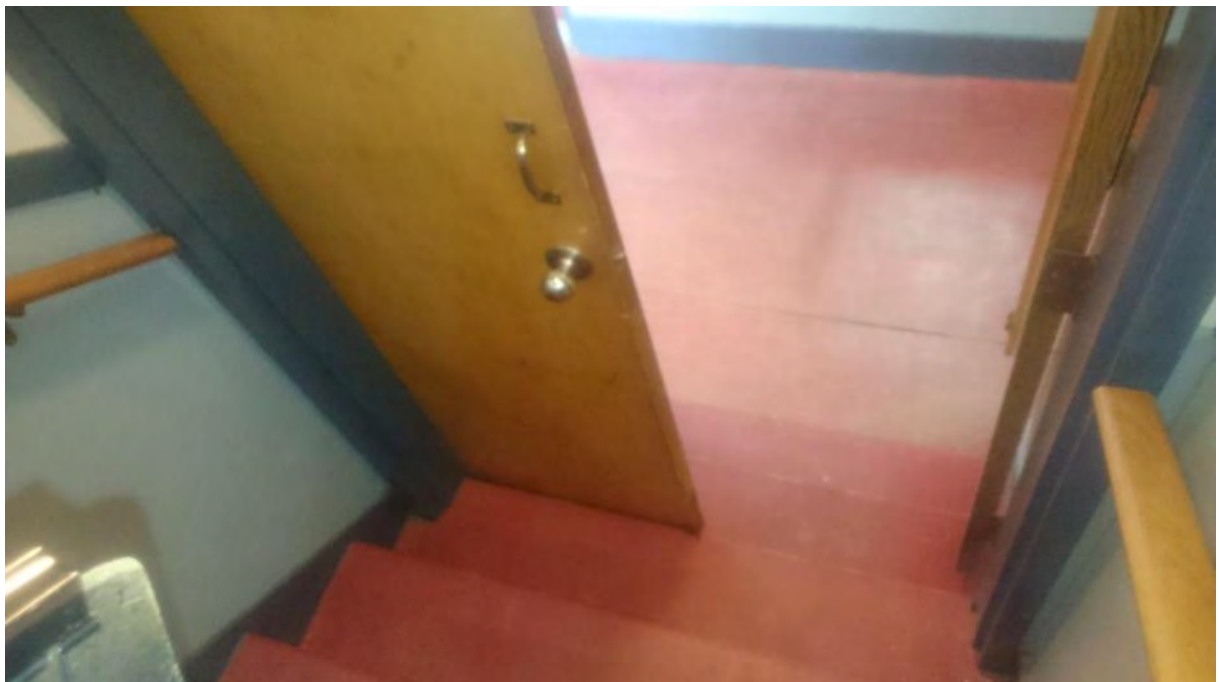
A8: Door to hospitality room, located on stairs

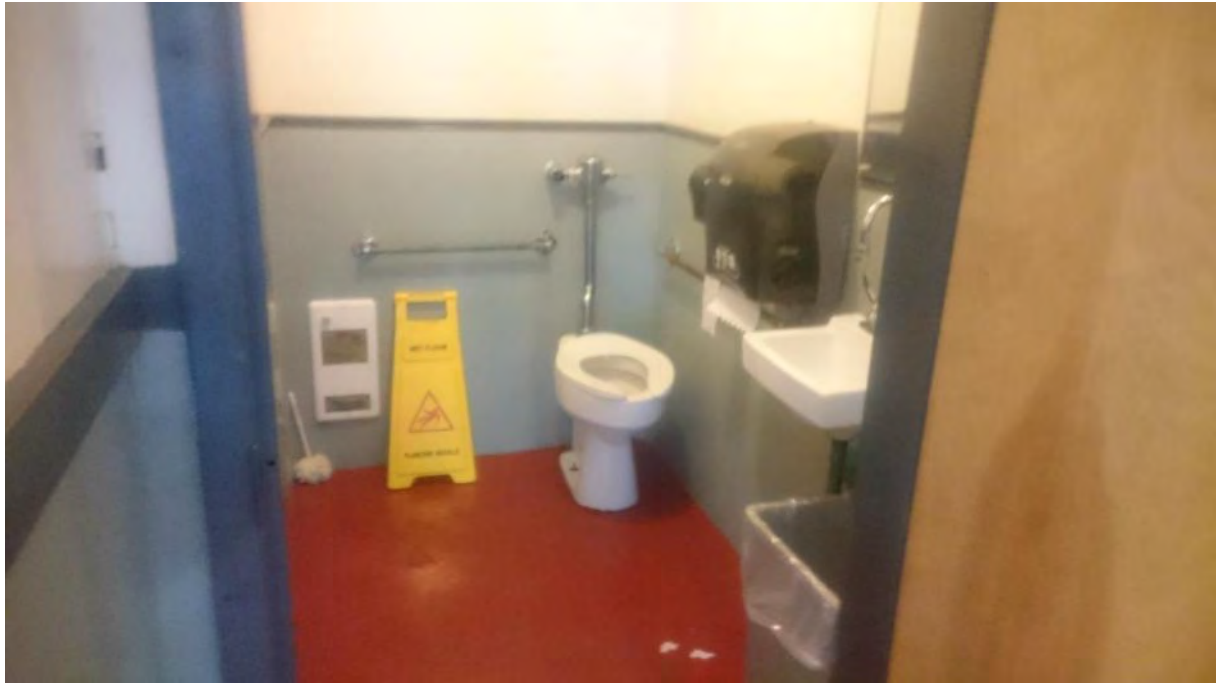
A9: Washroom off room #4. Door does not meet barrier-free requirements

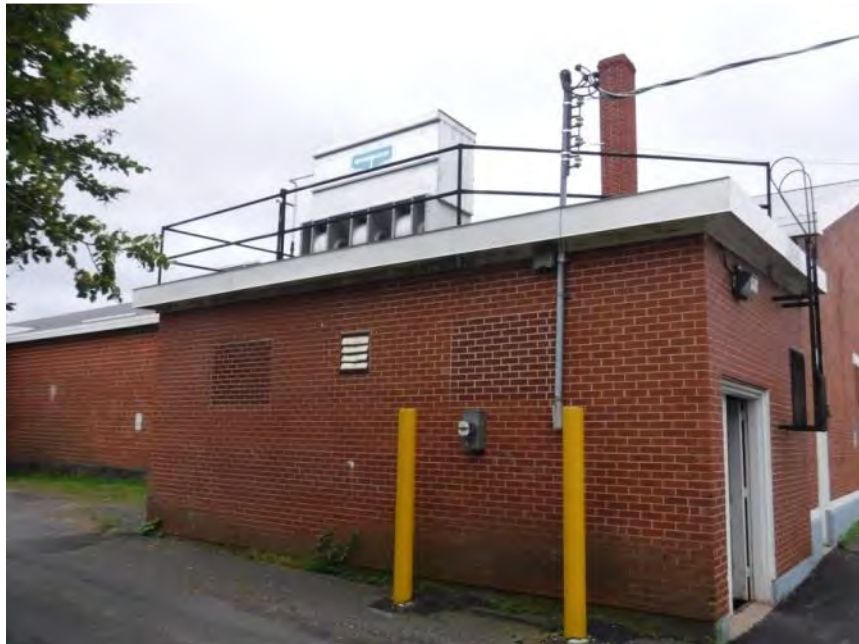
M2: Refrigeration Plant Gravity Backdraft damper damaged

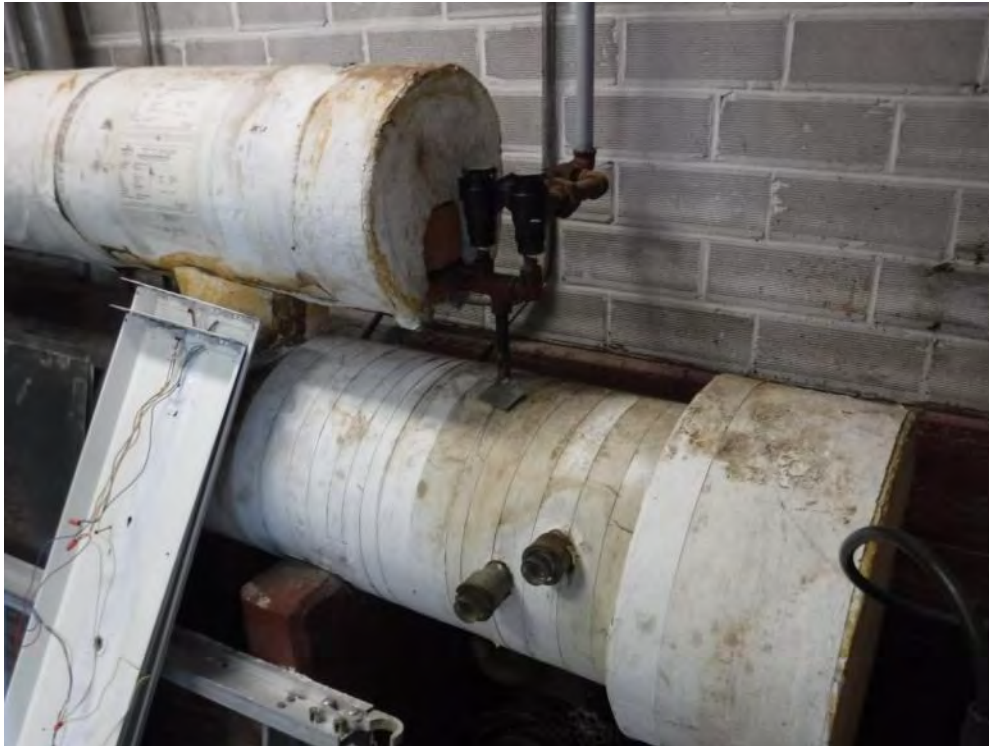
M5: Refrigeration Plant - Chiller with staging / light fixture leaning on equipment (installed in 1994)

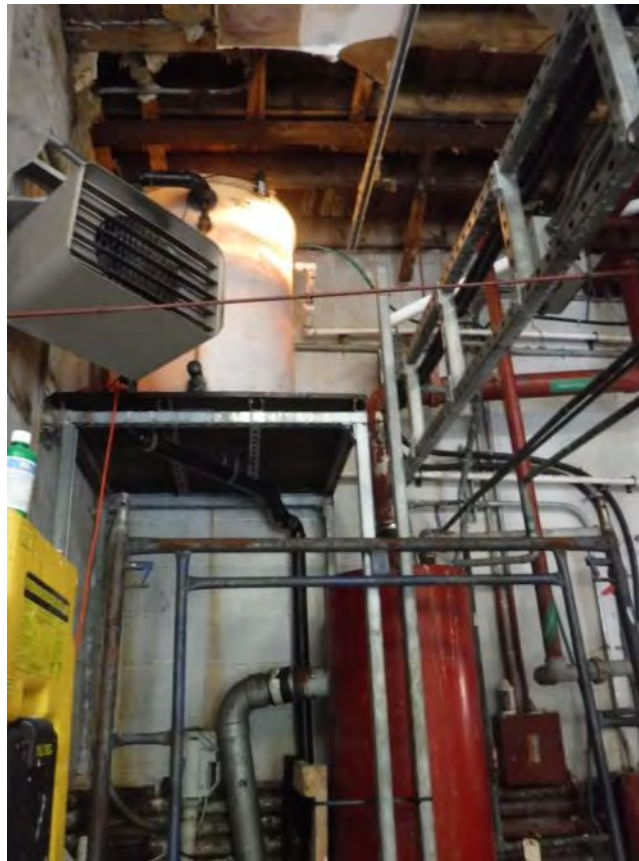
M7: Refrigeration Plant - Condenser water tank & mixing tank (note damage to ceiling)

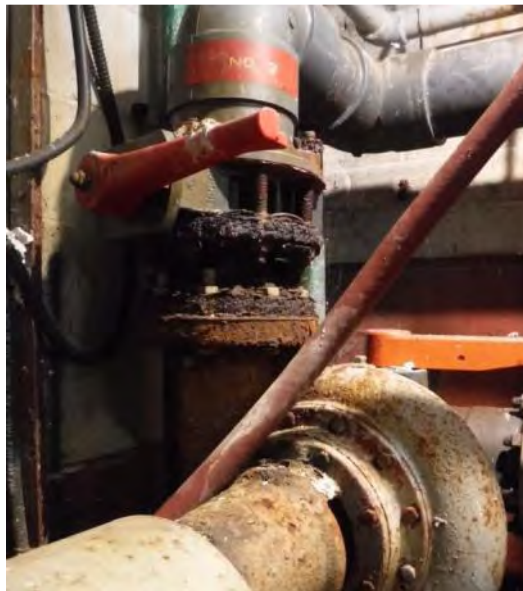
M9: Refrigeration Plant – Brine Pump #2 discharge steel adapter (severe corrosion)

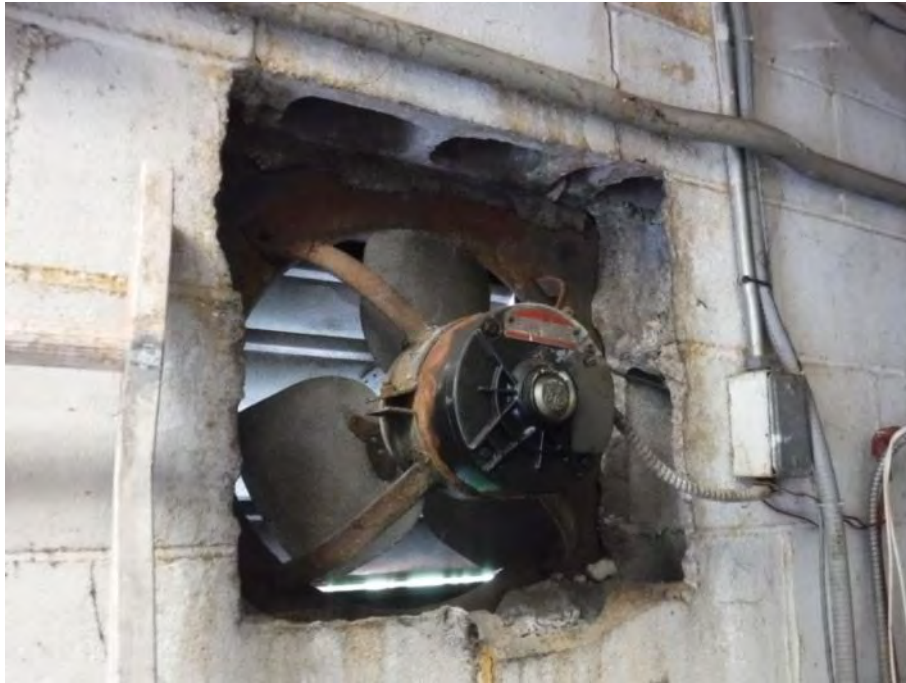
M10: Refrigeration Plant – Wall exhaust fan (require safety guard)

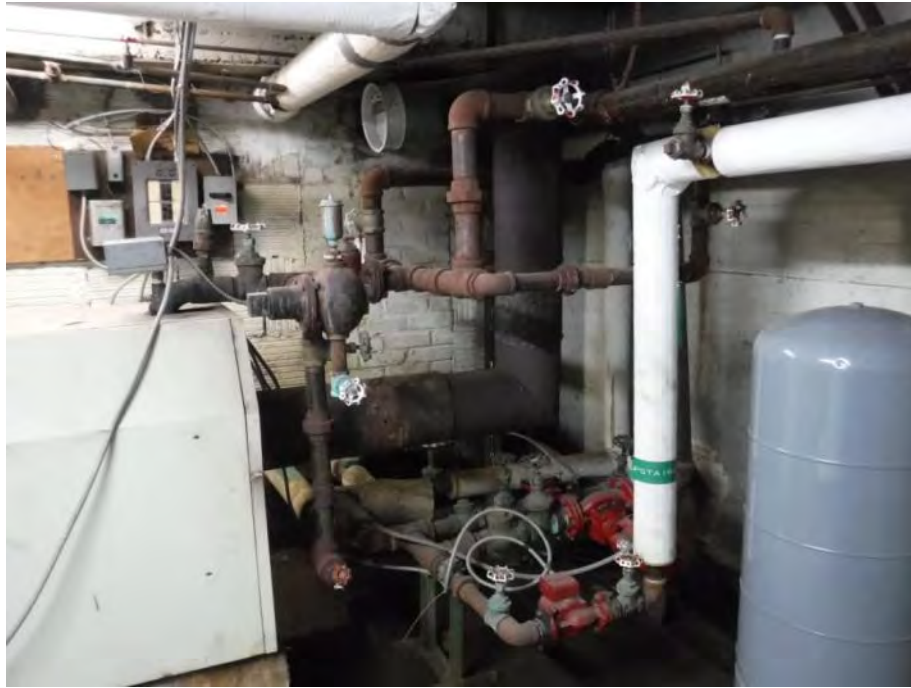
M12: Mechanical Room – Boiler System Breeching & Piping (breeching in poor condition)

- Repair & replacement of various low cost ventilation equipment
- Anchoring of fuel oil tanks & replacement of heating boiler breeching
- Testing existing backflow preventers & installation of new backflow preventer on Zamboni fill hose

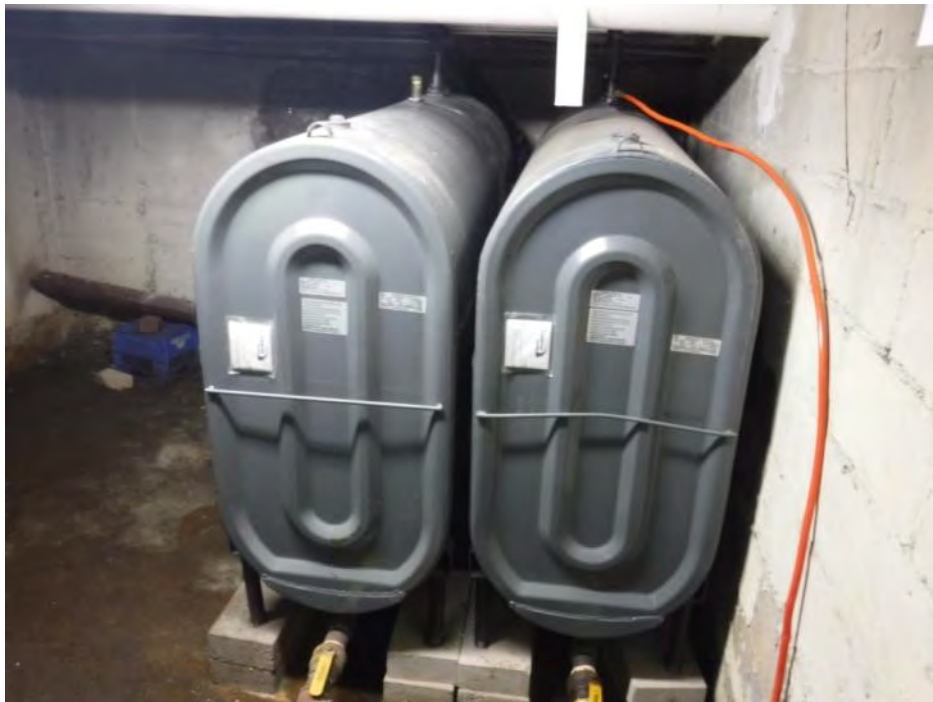
M13: Mechanical Room – Boiler System Fuel Tanks (tanks to be anchored to floor)

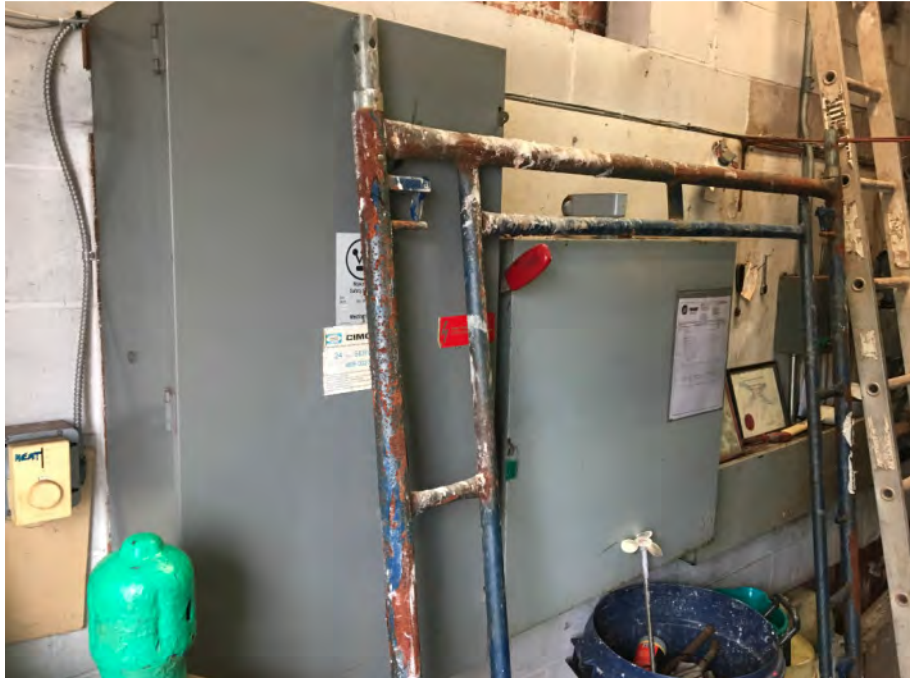
E1: Staging leaning on electrical equipment

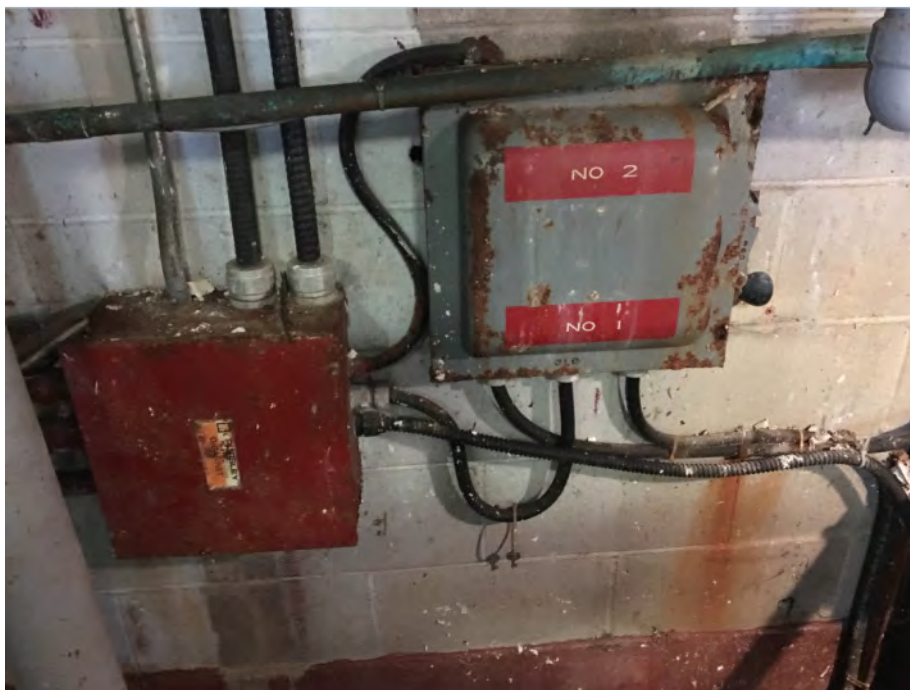
E2: Town Water line running on top of a 3-phase 600VAC manual Transfer Switch

- Replace and relocate the compressor manual transfer switch in a location away from water lines and maintain a minimum 1 meter unobstructed access in front of any electrical equipment

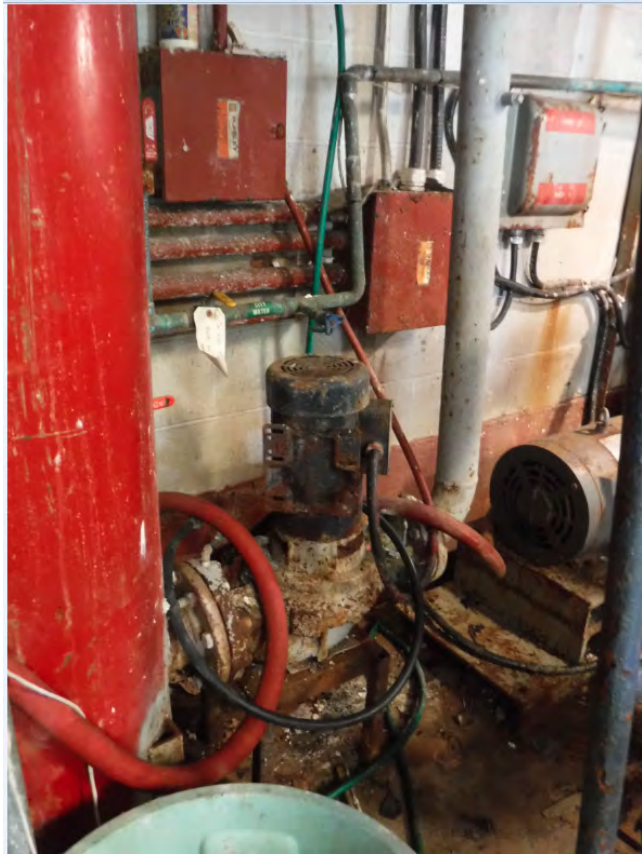
E3: Town Water line running on top of a 3-phase 600VAC manual Transfer Switch. Pipes obstruct one meter clearance in front of electrical equipment.

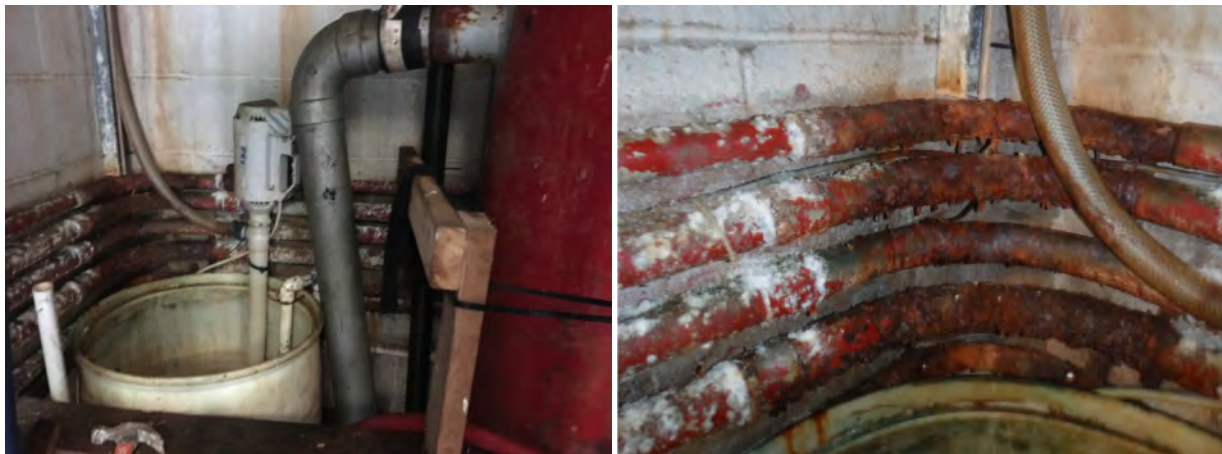
E4: Barrel used to mix brine beside heavily corroded electrical conduits

- Replace severely corroded steel columns in basement area
- Replacement of corroded electrical conduits in the ice plant
- Maintain good housekeeping with storage items away from electrical panels

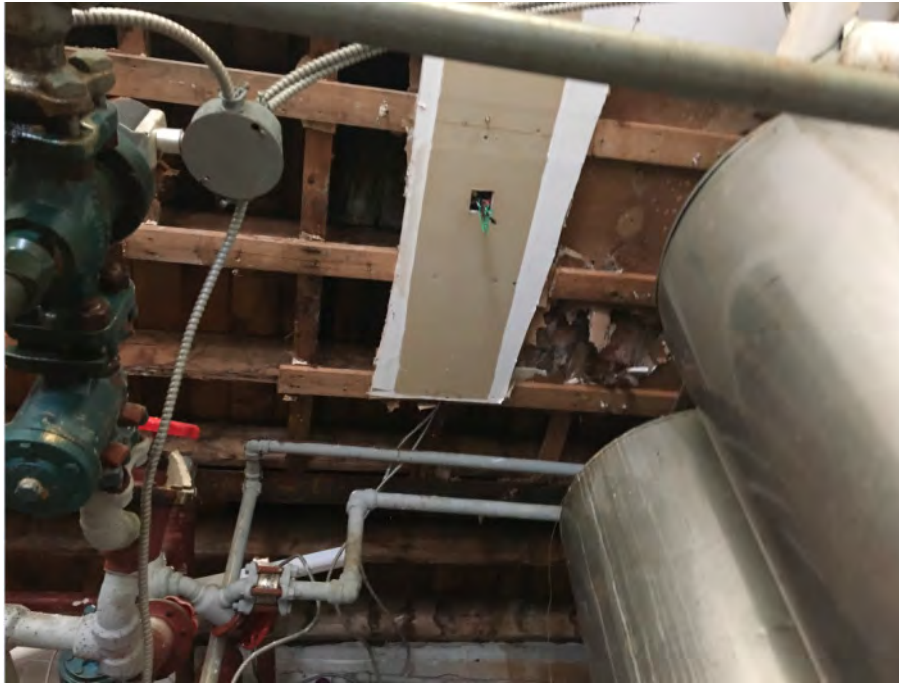
E5: Exposed wood ceiling in ice plant room near 600VAC equipment. One hour fire proof rated walls and ceiling is required.

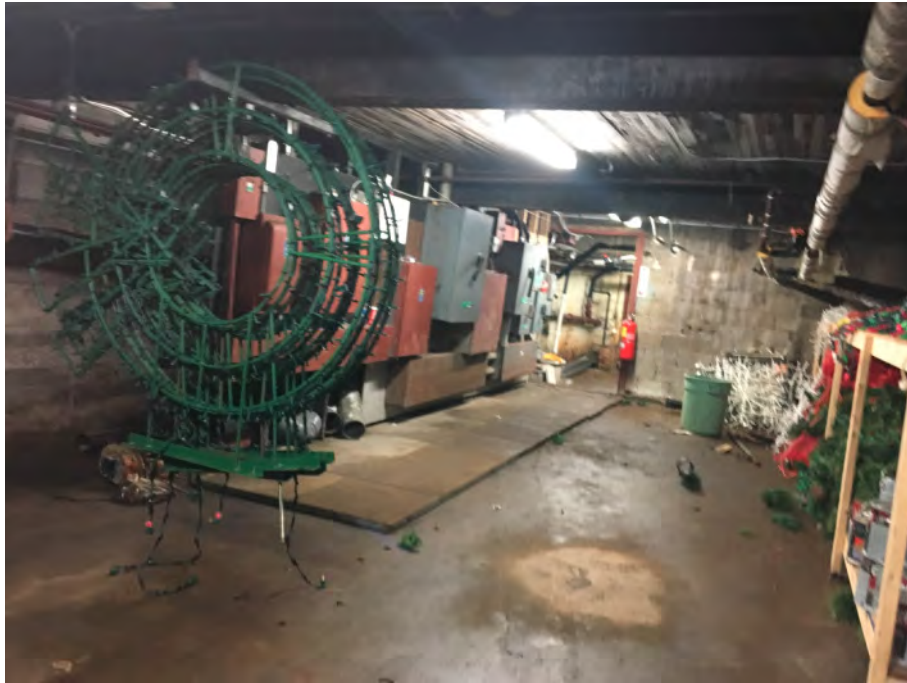
E7: Electrical Room used for storage

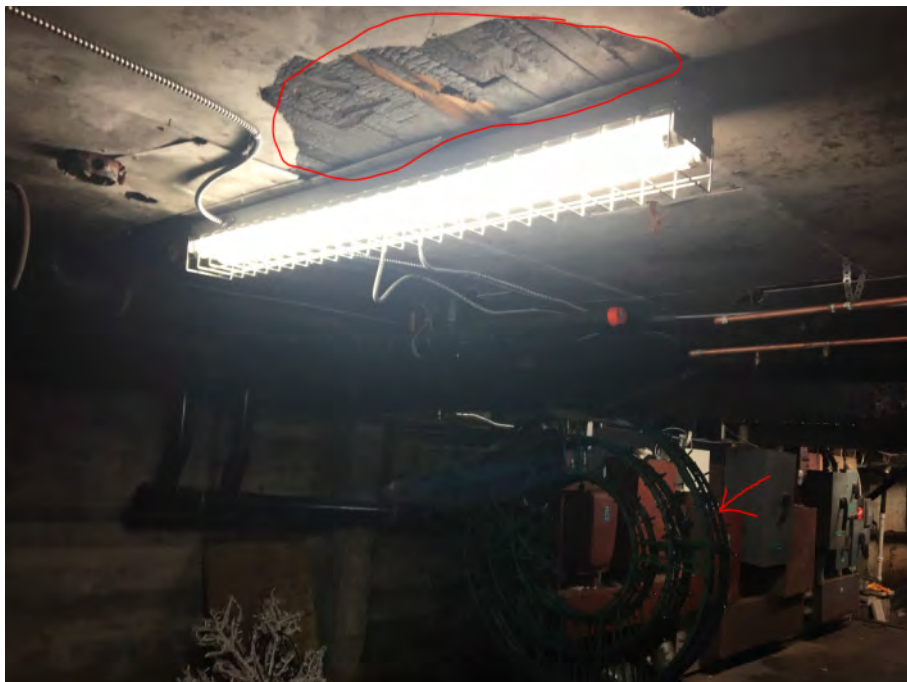
E8: One hour fire rating compromised by a previous fire

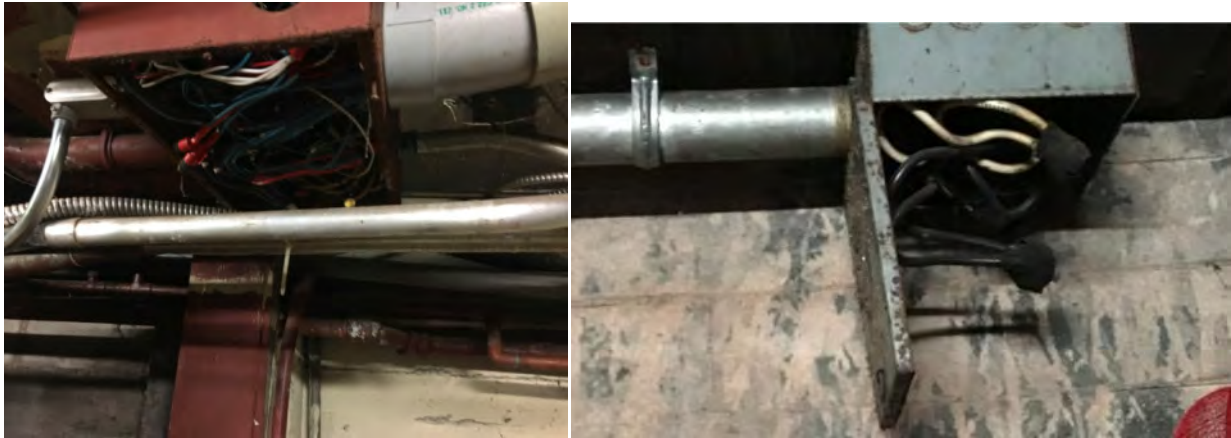
E9: Exposed wires, no cover on enclosures

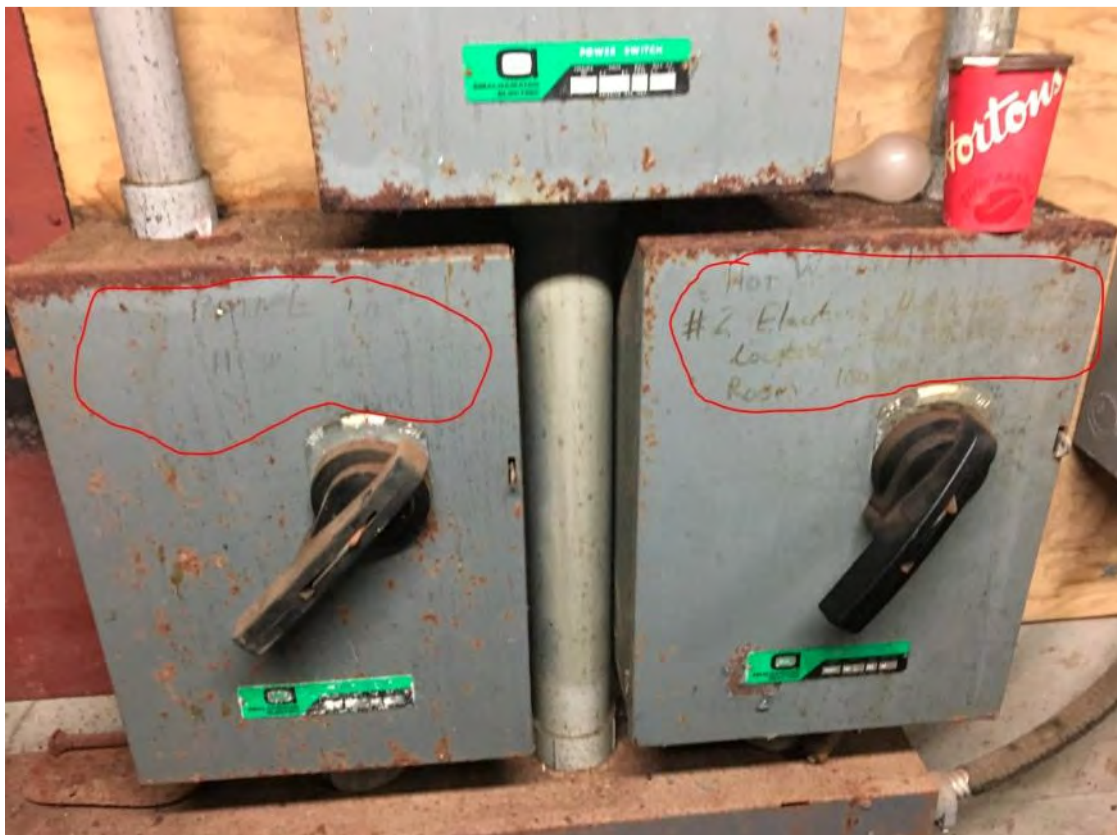
E10: Disconnect Switches labeled with Sharpie. No Electrical shock or arc flash warnings

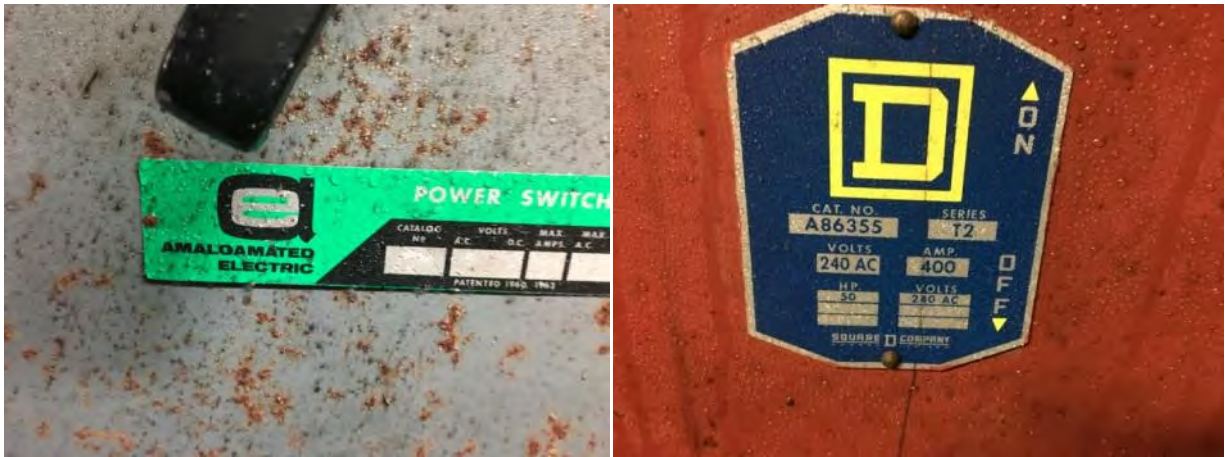
E11: Water condensing on metal Type 1 electrical enclosures due to lack of ventilation

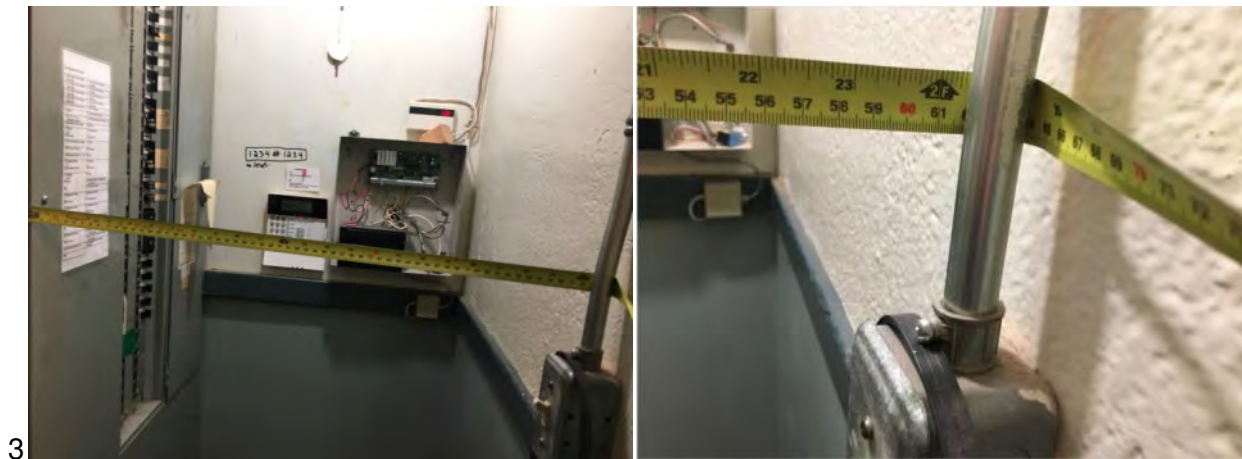
E12: Electrical Panel by ticket booth has less than one meter clearance

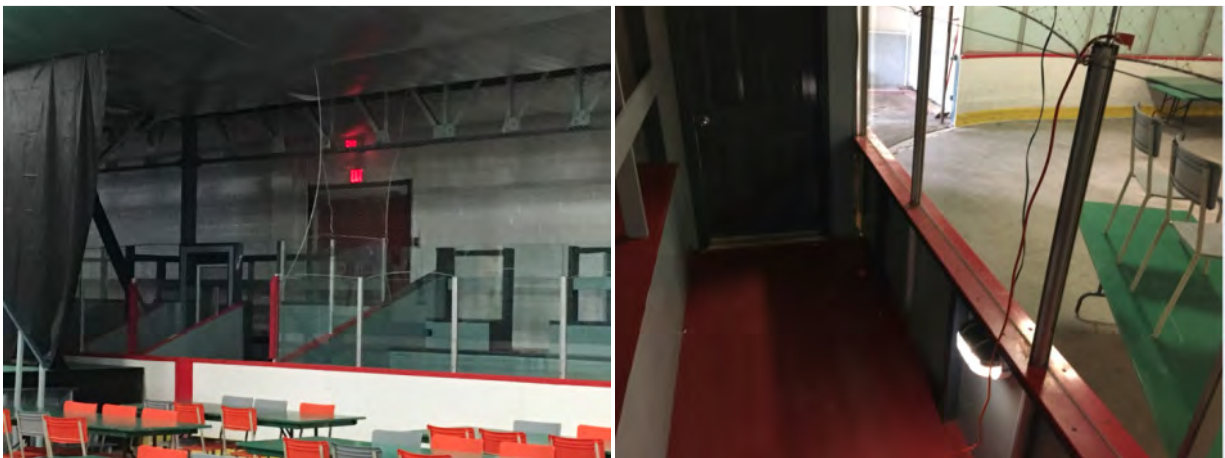
E13: Dim lighting in bleacher area

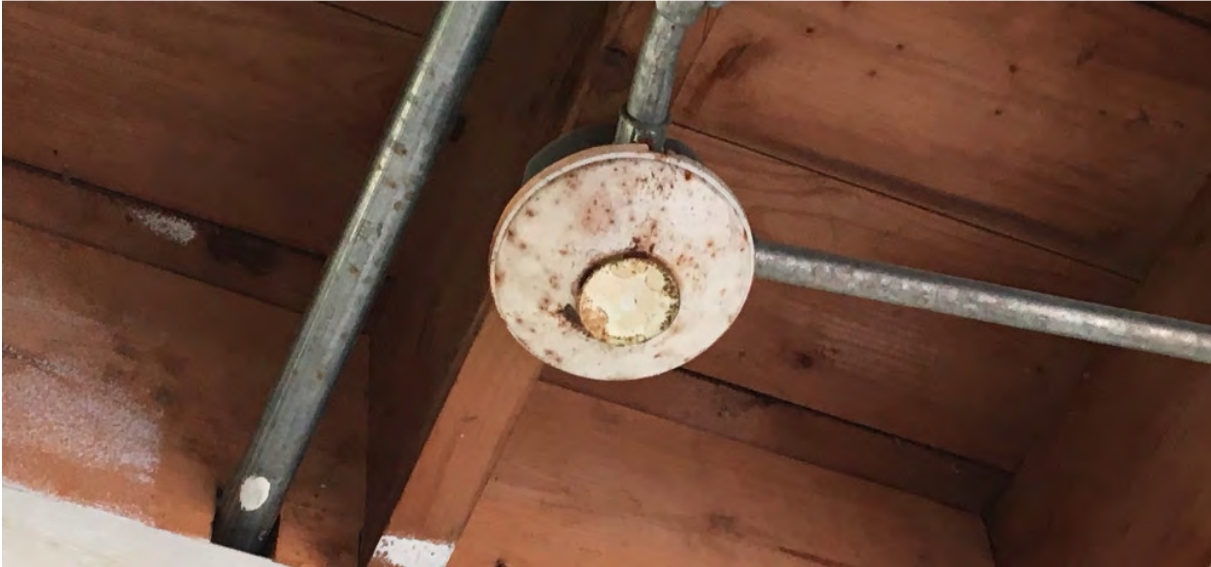
E14: Smoke detectors are well past 10 year replacement recommendation

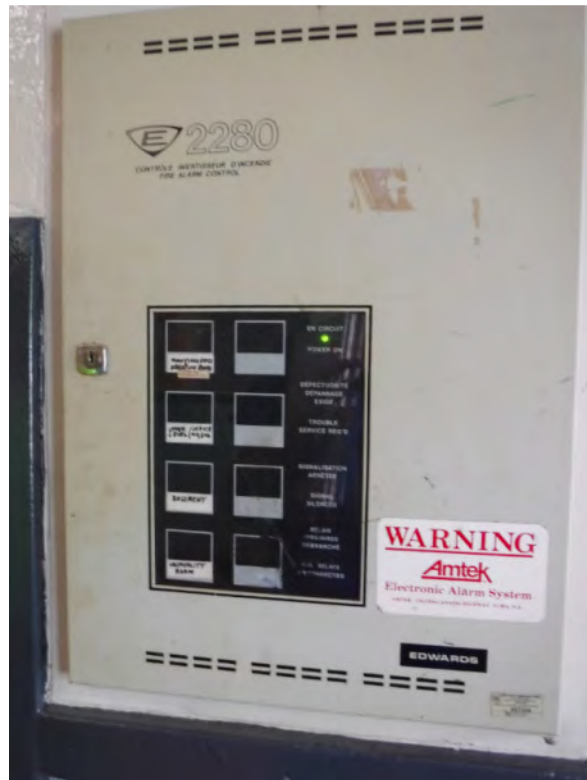
E15: Aging fire alarm panel

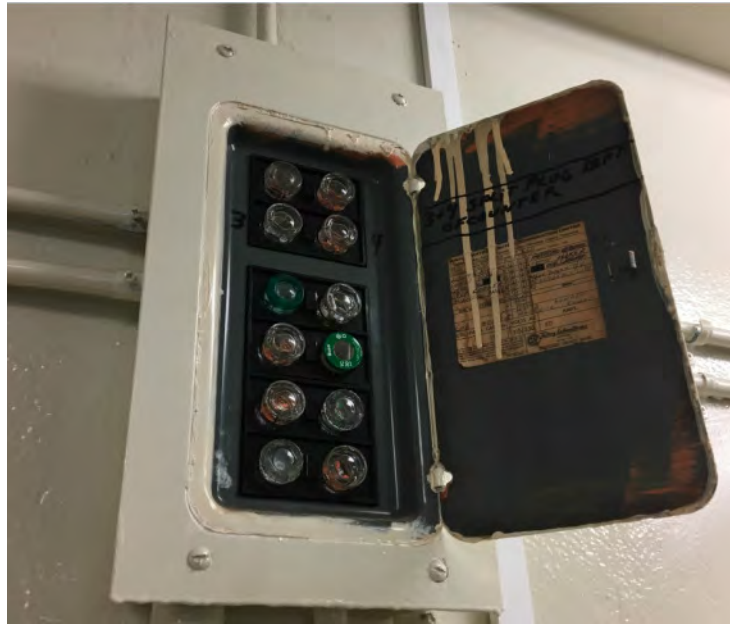
E16: Canteen fused panel. Consider replacing with a circuit breaker panel

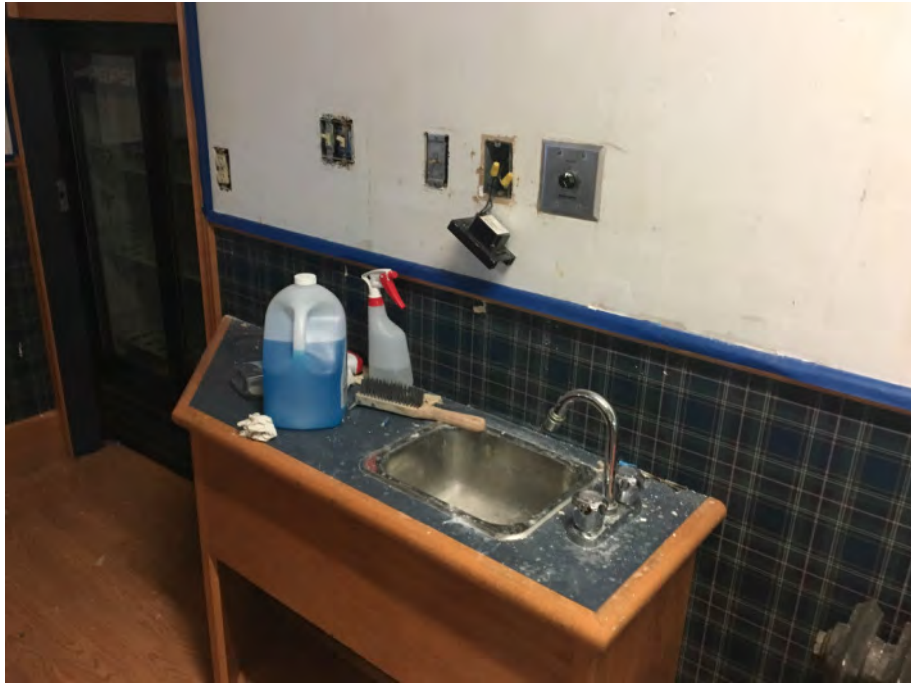
E18: Electrical switches and receptacles within 1 meter of a sink with no ground fault protection

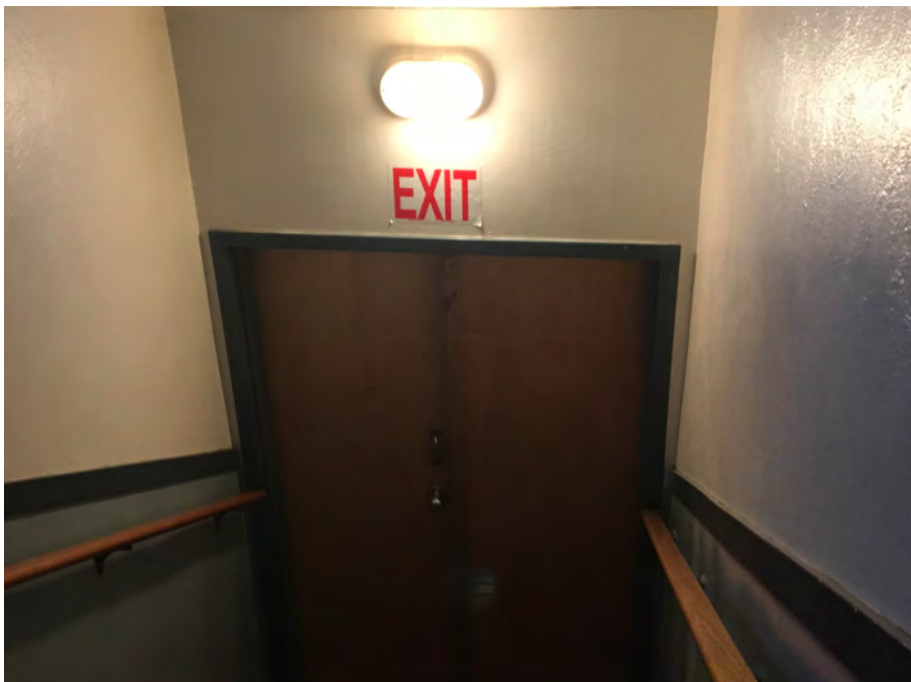
E19: No emergency lighting at mezzanine exit
