# Aging Building Audit

## Stellarton Memorial Rink - Final Report

Town of Stellarton

Report > Rev. C01  
Internal ref. 657583-0001-T-31-REP-000-0001

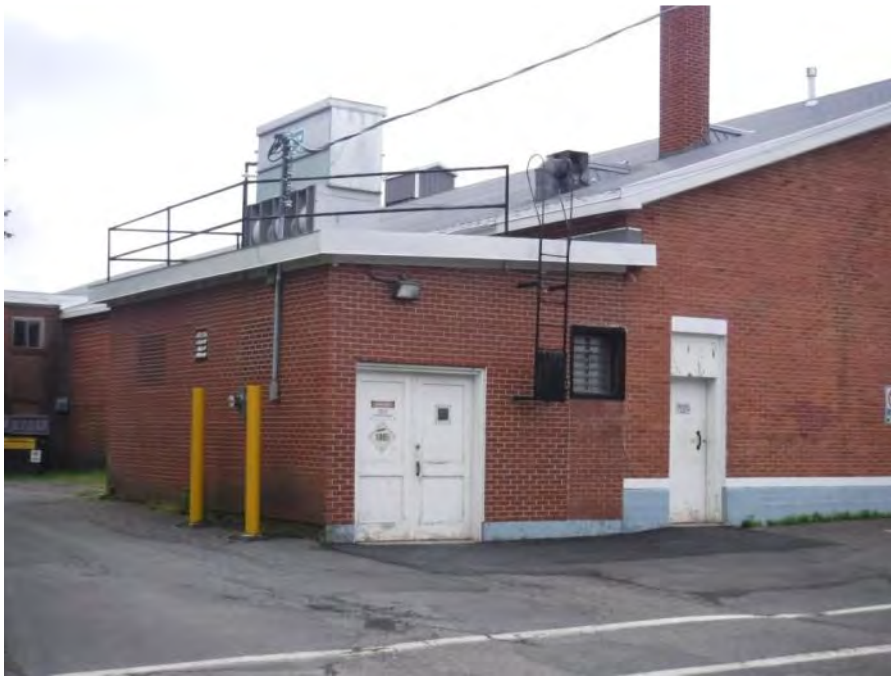
M1: Refrigeration Plant view from the street. Evaporator located on Roof

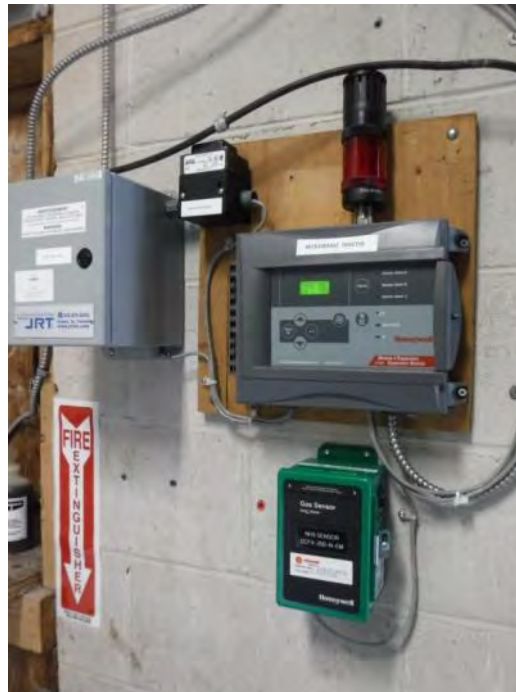
M3: Refrigeration Monitoring System (installed in 2018)

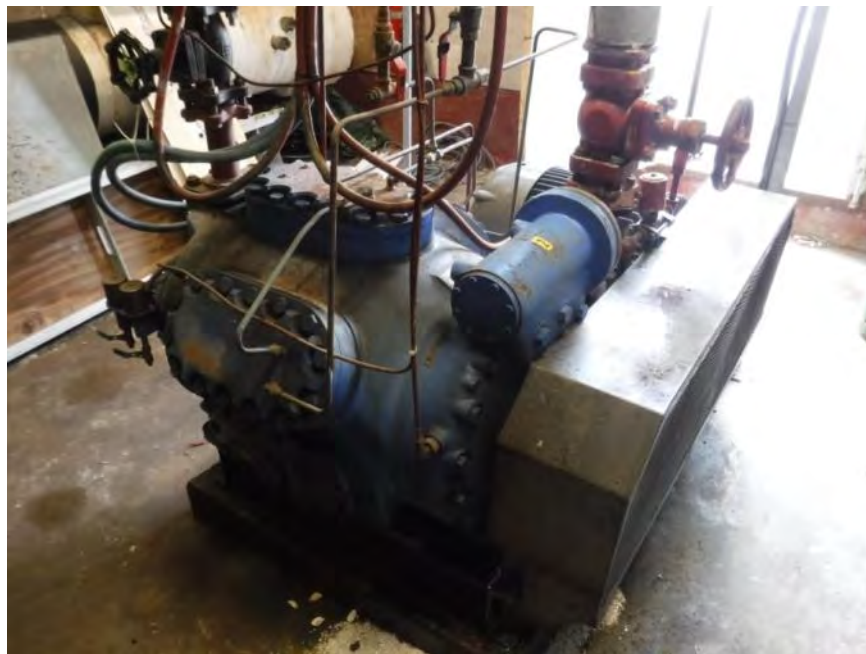
M4: Compressor #2 - J&E Hall 50 hp (installed in 1980)

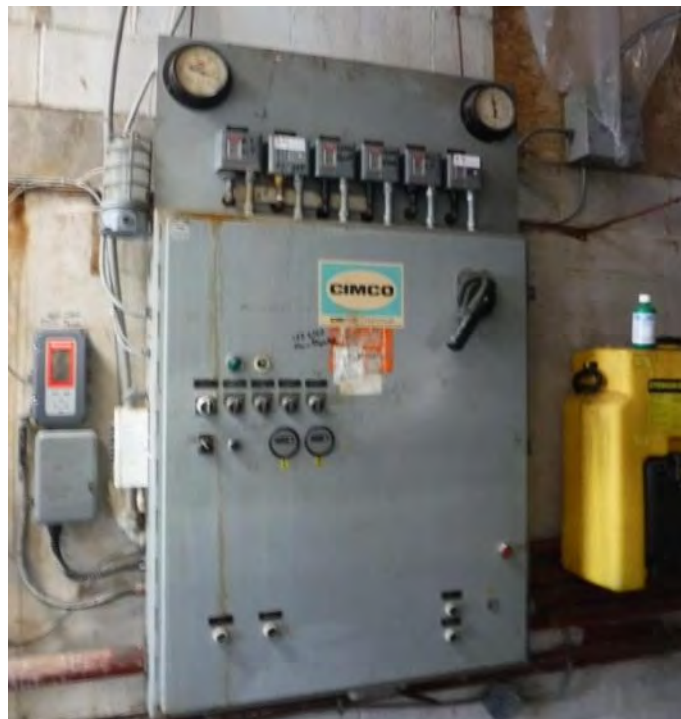
M6: Refrigeration Plant Control Panel

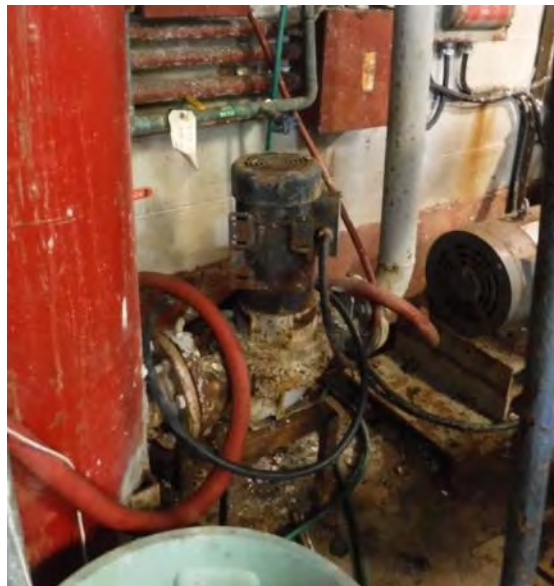
M8: Refrigeration Plant - Condenser Water Pump (installed in 2003)

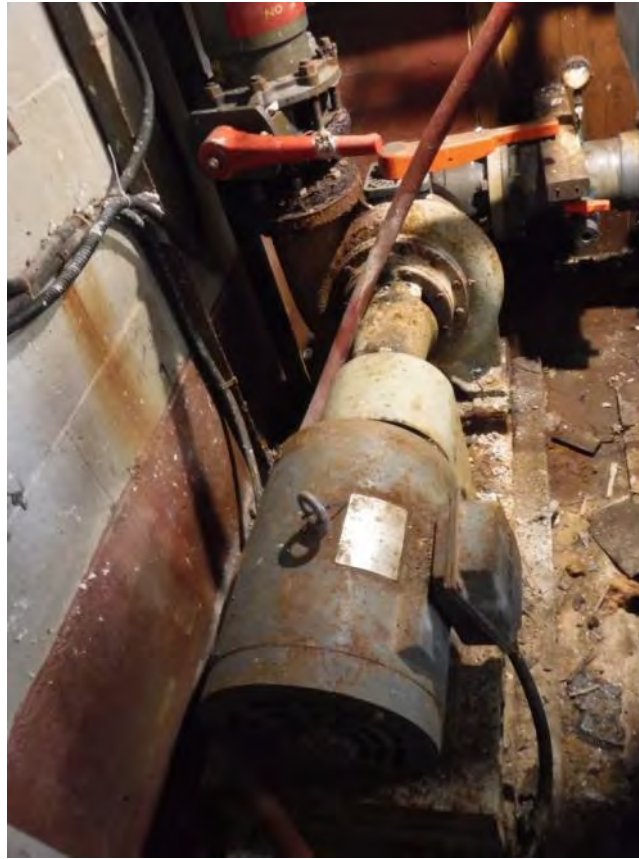
M8: Refrigeration Plant – Brine Pump #2 (installed 1985)

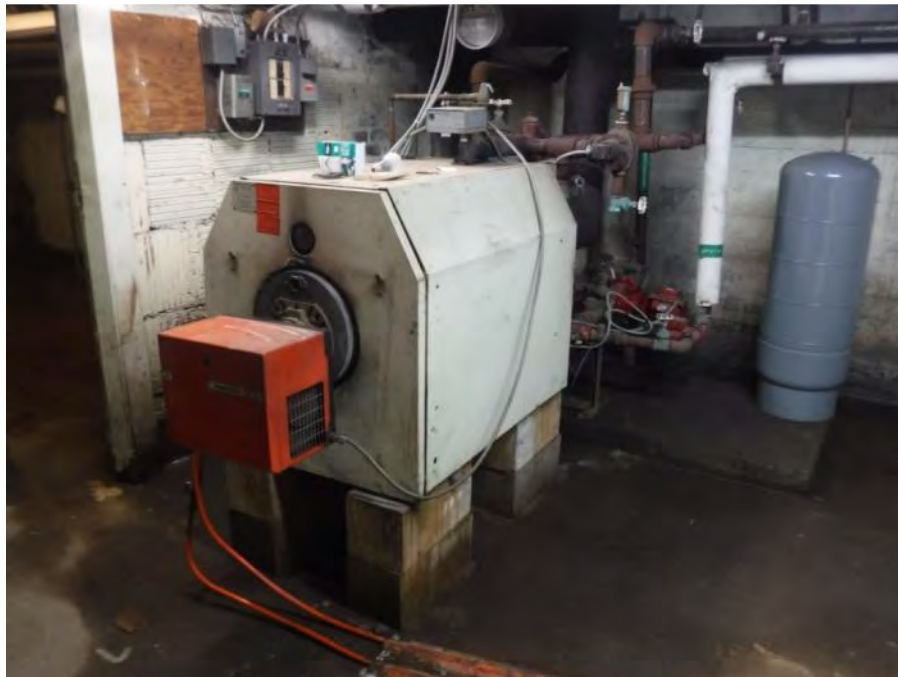
M11: Mechanical Room – Boiler System

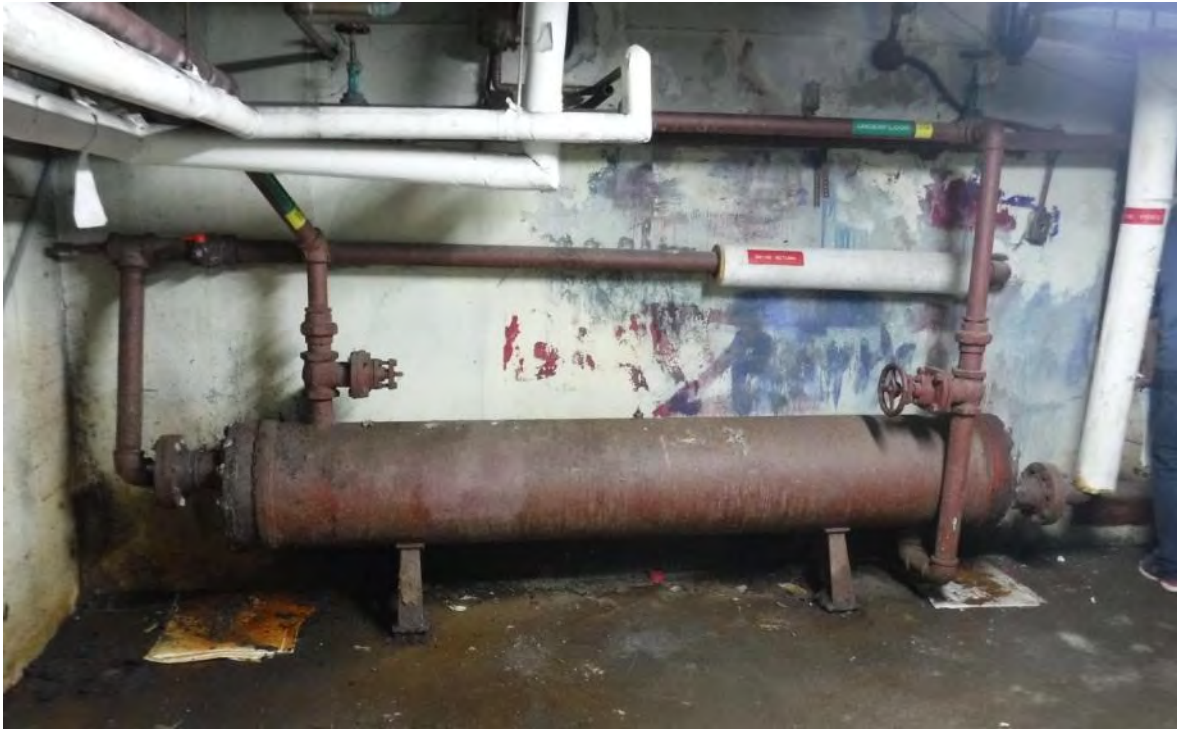
M14: Mech. Room – Ice Surface Heat Exchanger for converting to in-Floor heating with Boiler Water

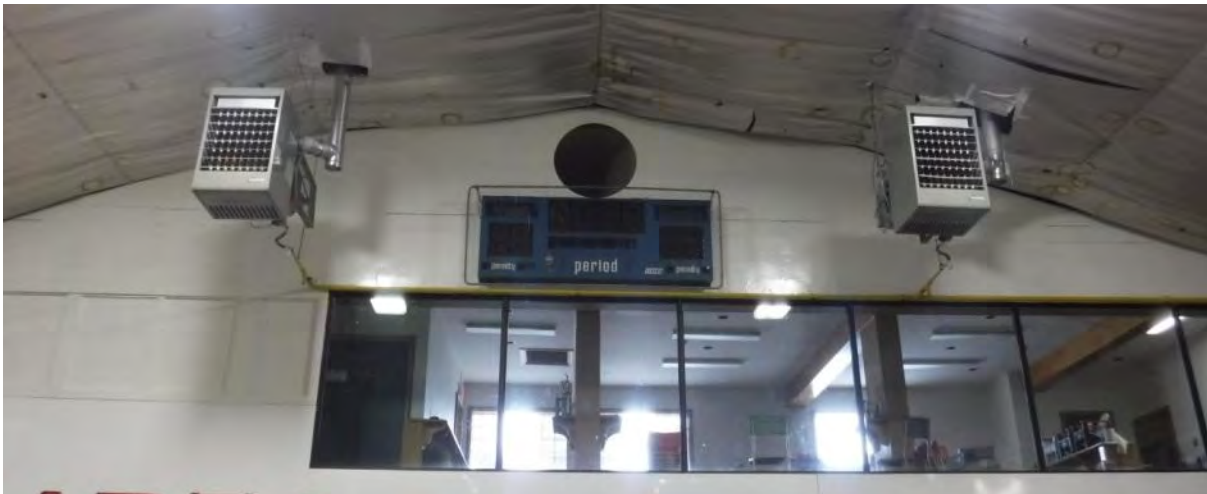
M15: Ice Surface Force Air Unit Heaters – Required for supplementary heat during non-Ice Season

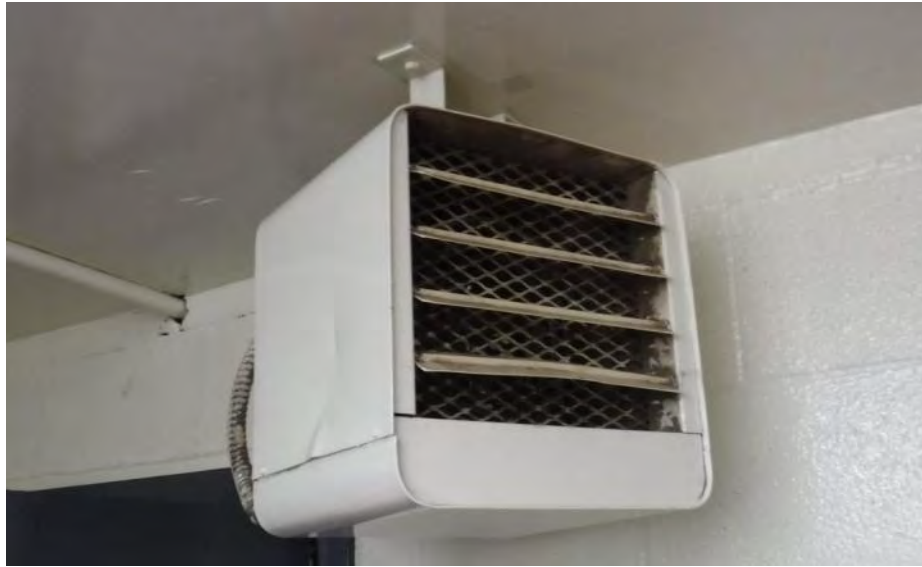
M16: Dressing Room – Electric Unit Heater

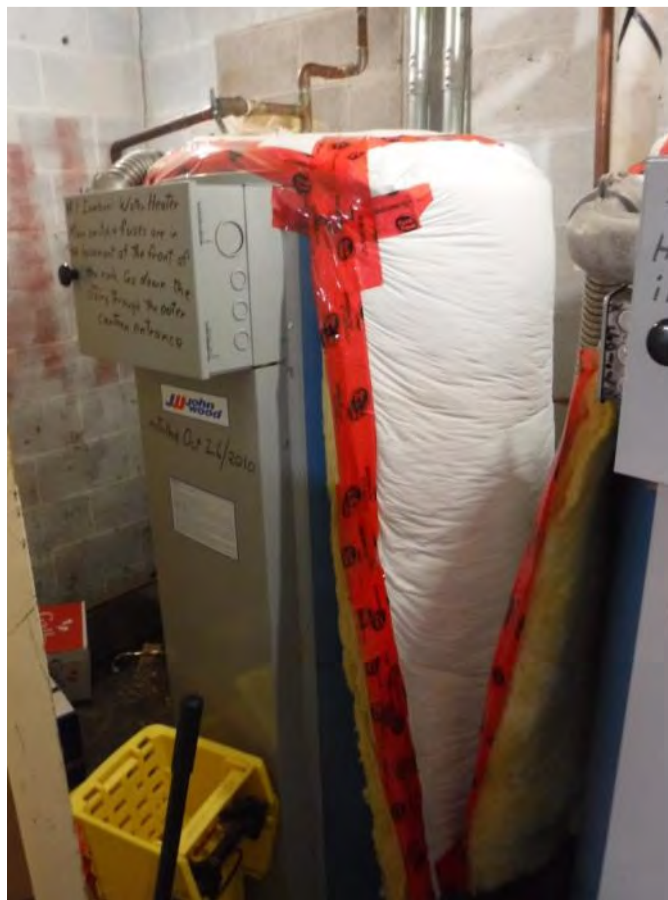
M17: Ice Resurfacing DHW heaters

Mechanical	Ventilation		1	Inspect & repair exhaust ventilation in the dressing rooms, washrooms. Replace as required.	\$ 2,500
Mechanical	Ice Resurfacing		1	Relocate & replace if necessary P&T safety valves on DHW tanks	\$ 500
Mechanical	Space Heating		1	Anchor existing fuel tanks to concrete floor	\$ 1,000
Mechanical	plumbing		1	Annually test backflow preventers	\$ 500
Mechanical	plumbing		1	Replace floor drains in washrooms (painted-over)	\$ 500
Mechanical	Ventilation		1	Install exhaust ventilation in office 'pink' washroom	\$ 500
Mechanical	Ventilation		1	Replace gravity backdraft damper & install safety guard on wall fan in Refrigeration plant	\$ 500
Mechanical	Ice Resurfacing		1	Install vacuum breaker on Zamboni fill hose	\$ 100
Struct/Arch	Interior		1	In hospitality room, provide guard rail at window	\$ 3,000
Structural	Masonry/Brick	S13-17	1	Remove speed tile/brick exterior walls, reinstate with concrete block/brick wall (Alternative 1)	\$1,050,000

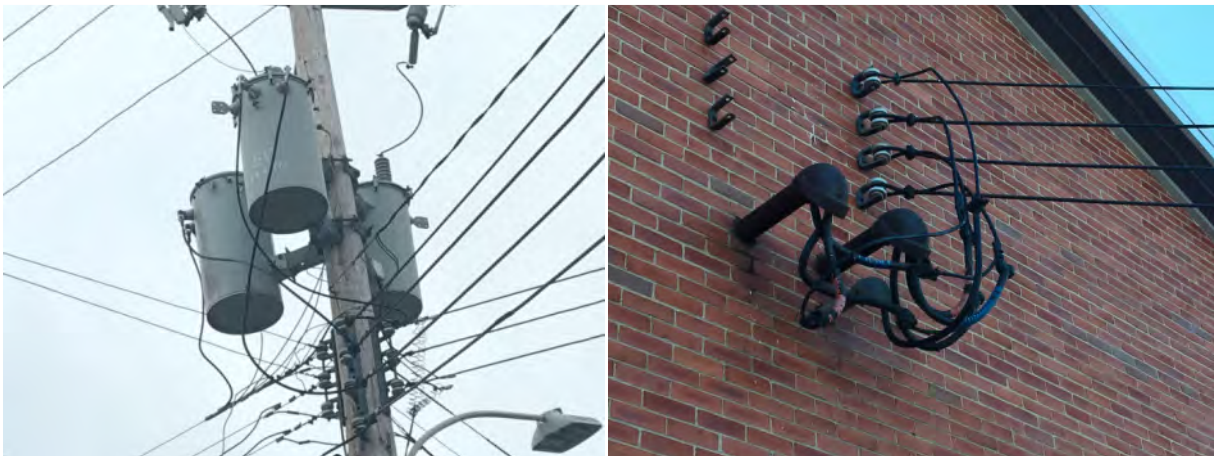
E6: 600/208-120VAC 3 phase 4 wire building electrical entrance
