# Aging Building Audit

## Stellarton Memorial Rink - Final Report

Town of Stellarton

Report > Rev. C01  
Internal ref. 657583-0001-T-31-REP-000-0001

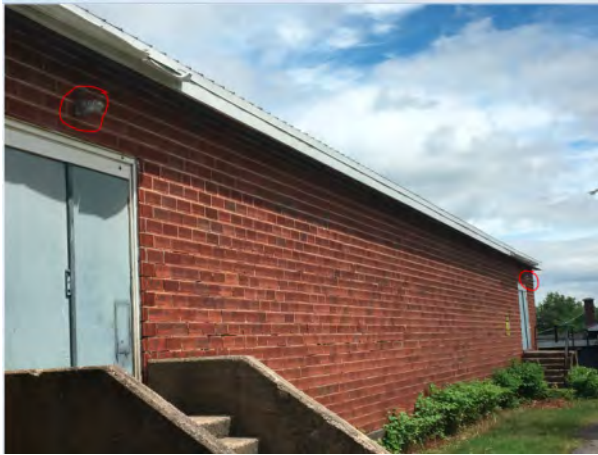
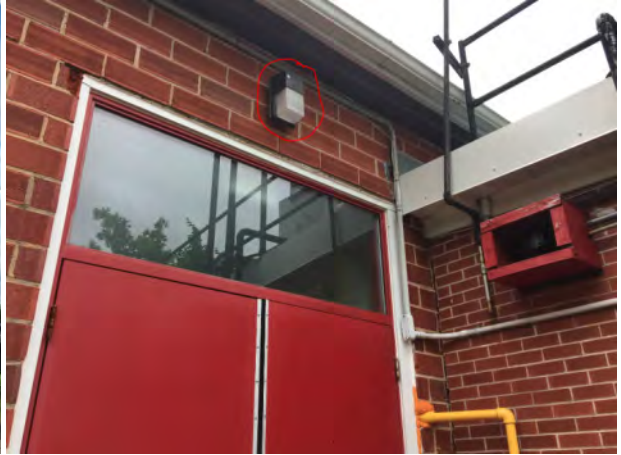
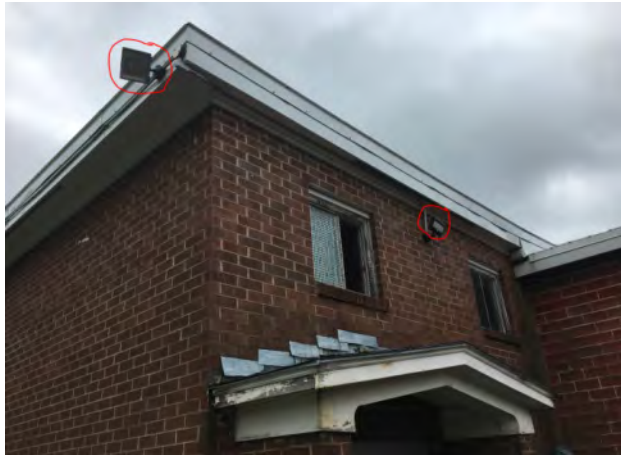
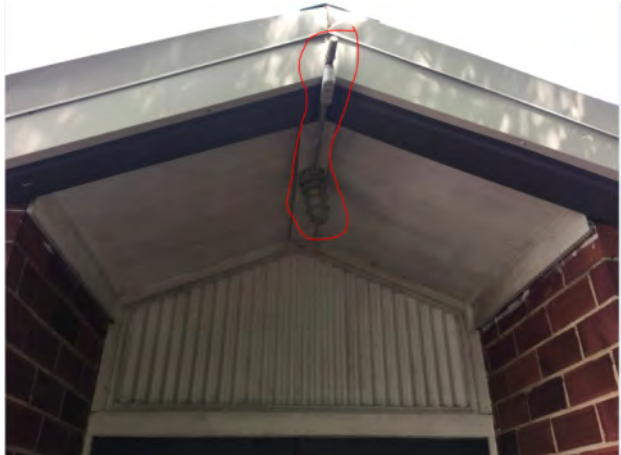
E17: Inconsistent outside lighting

1. Replace the existing outdoor light fixtures around the building with new photo eye controlled LED fixtures on a timed controller. This is a Priority 1 equipment replacement recommendation. The cost is estimated to be \$10,000.
